GUIDANCE DOCUMENT

External Fire Exposure of Roof Decks within a Roof Build-Up

INDICATIVE TEST RESULTS – Penetration test trials on 4 types of substrate based on BS 476-3 & CEN/TS 1187 Test 4.

Indicative test Report No. 20776A

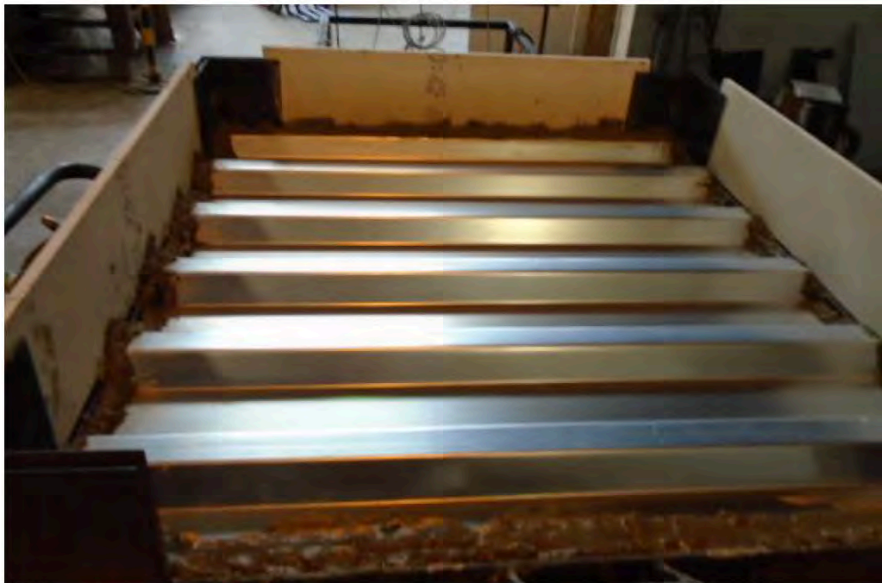
Figure 1- test specimen 1 immediately prior to test.

Sample reference	Penetration min:s	Observations
E10979-1	None	No ignition or degradation of specimen visible.
E10979-2	None	No ignition or degradation of specimen visible.

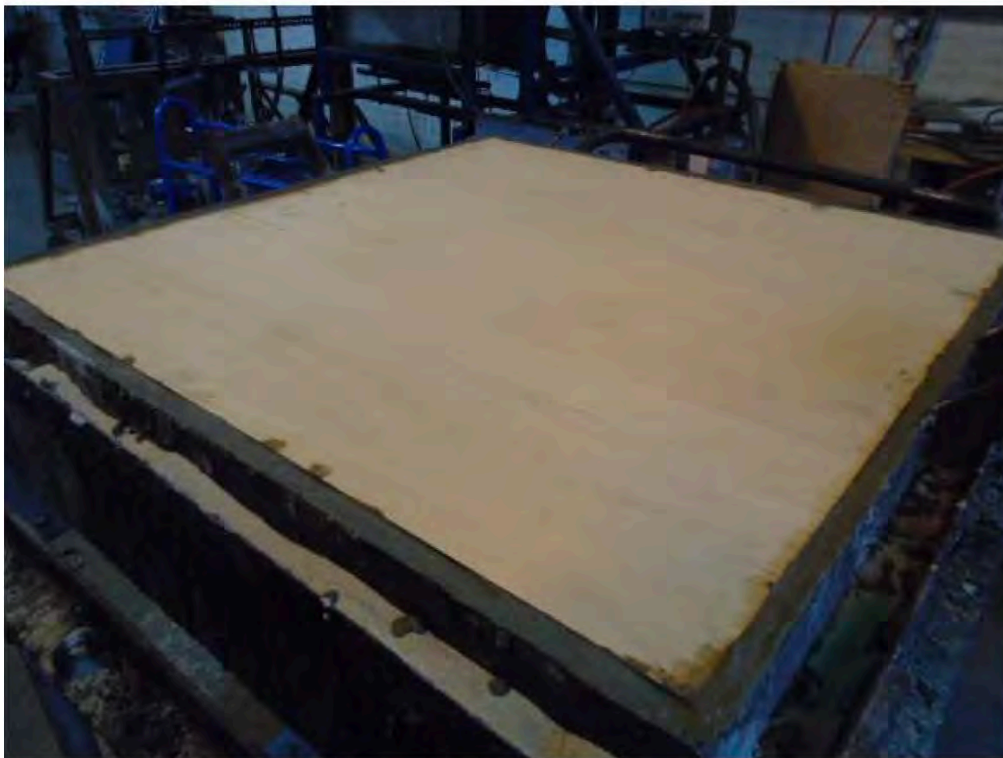
Figure 3- plywood specimen as installed prior to testing.

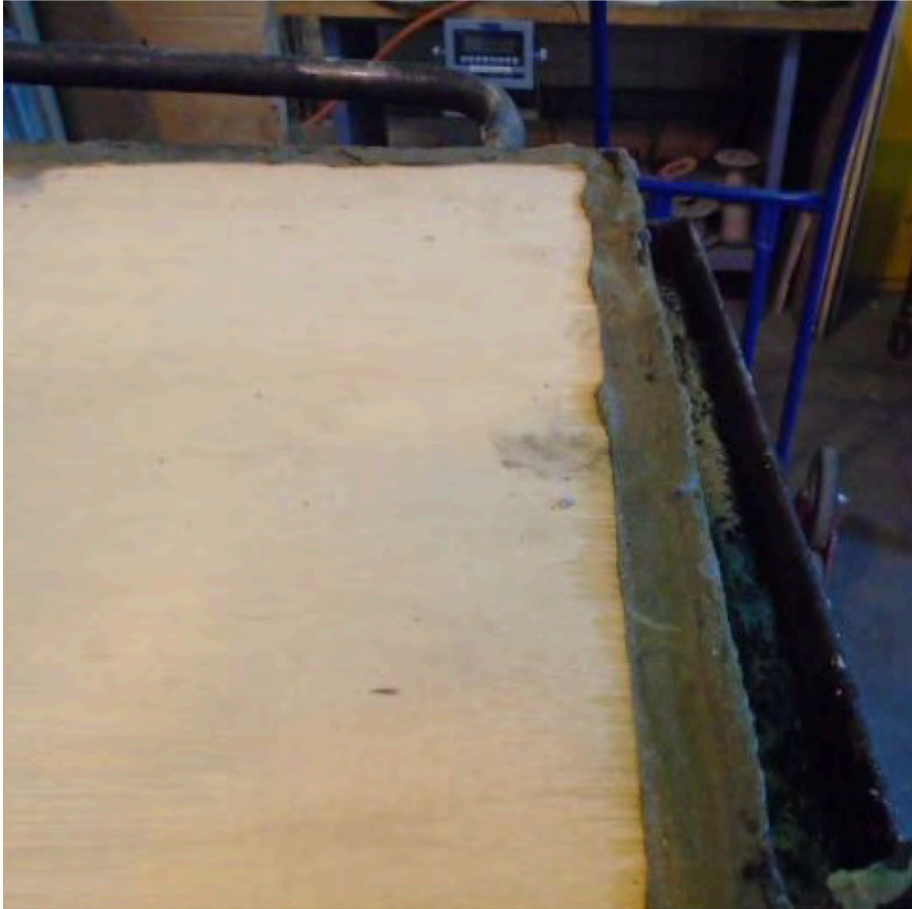
Figure 4- showing edge detail prior to testing.

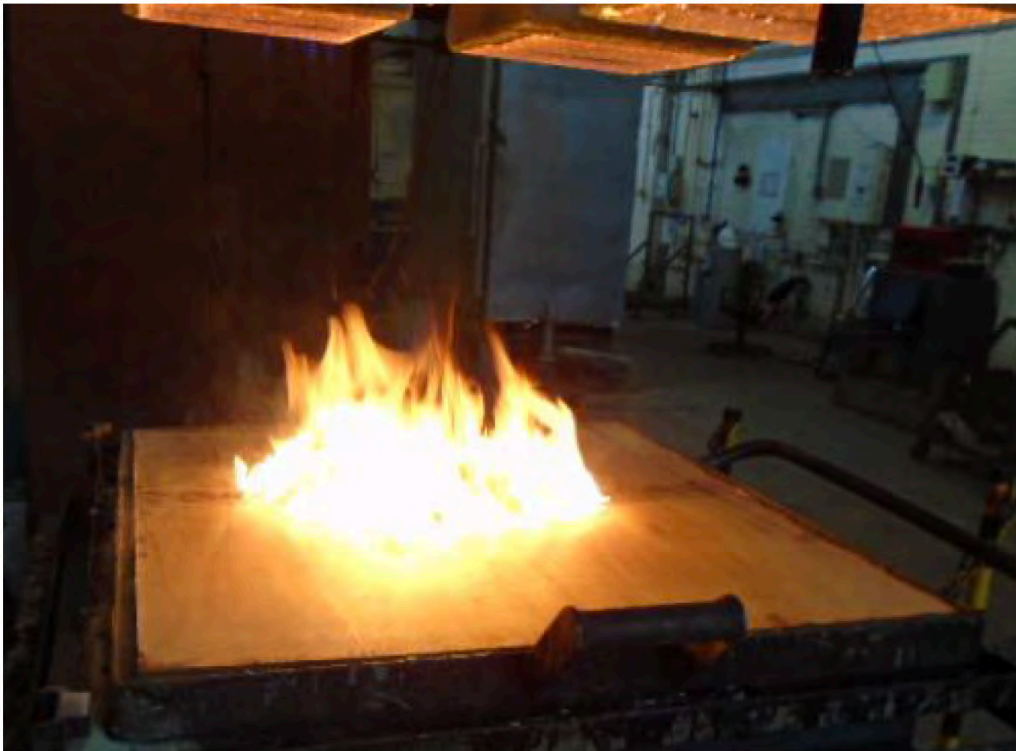
Figure 5- flaming shortly after ignition with pilot flame at 5-6 minutes.

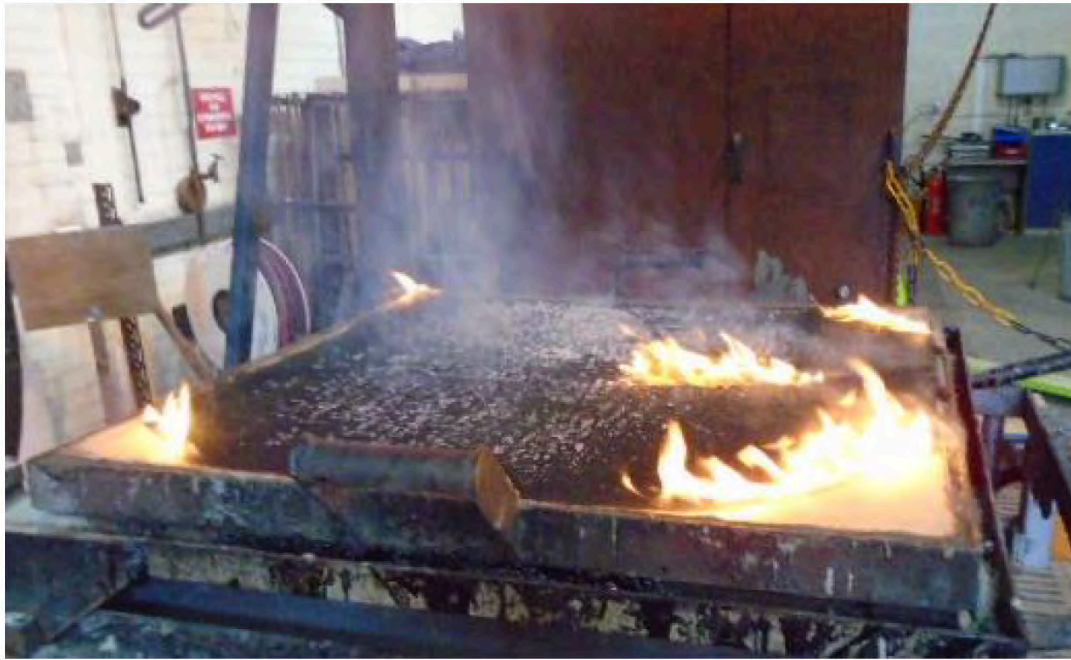
Figure 6- flaming subsiding at 10 minutes.

Sample reference	Penetration min:s	Observations
E11180-1	40:05	Flexing of plywood was observed, sufficient to break the cement seal by 10 mins. Visible flaming ceased at 13:29 minutes. The specimen had visibly cracked open by 40:05 showing glowing on the edges and underside.
E11180-2	43:23	Flexing of plywood was observed, sufficient to break the cement seal by 8 mins. Visible flaming ceased at 12:20 minutes. Severe warping of the specimen occurred by 30 minutes. The specimen collapsed at 43:25 leaving visible glowing on the remaining edges and underside.

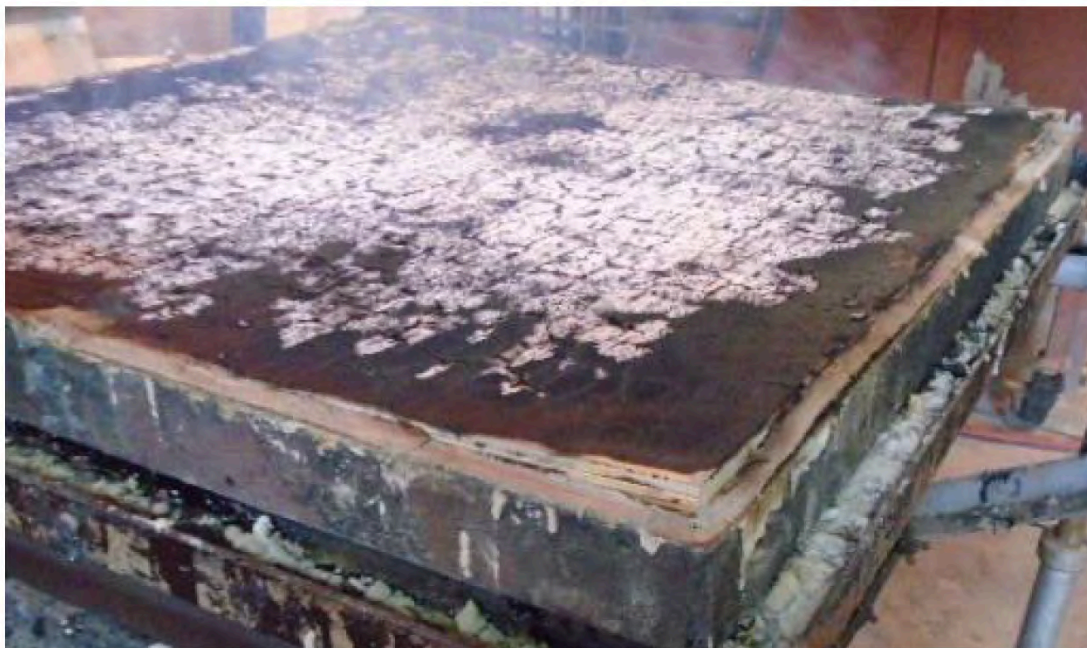
Figure 7- showing edge seal failure.

Note:- the breaking of the edge seals would cause an X suffix to be added to any BS 476 classification, and observations of the same to be added to any EN 1187-t4 report.

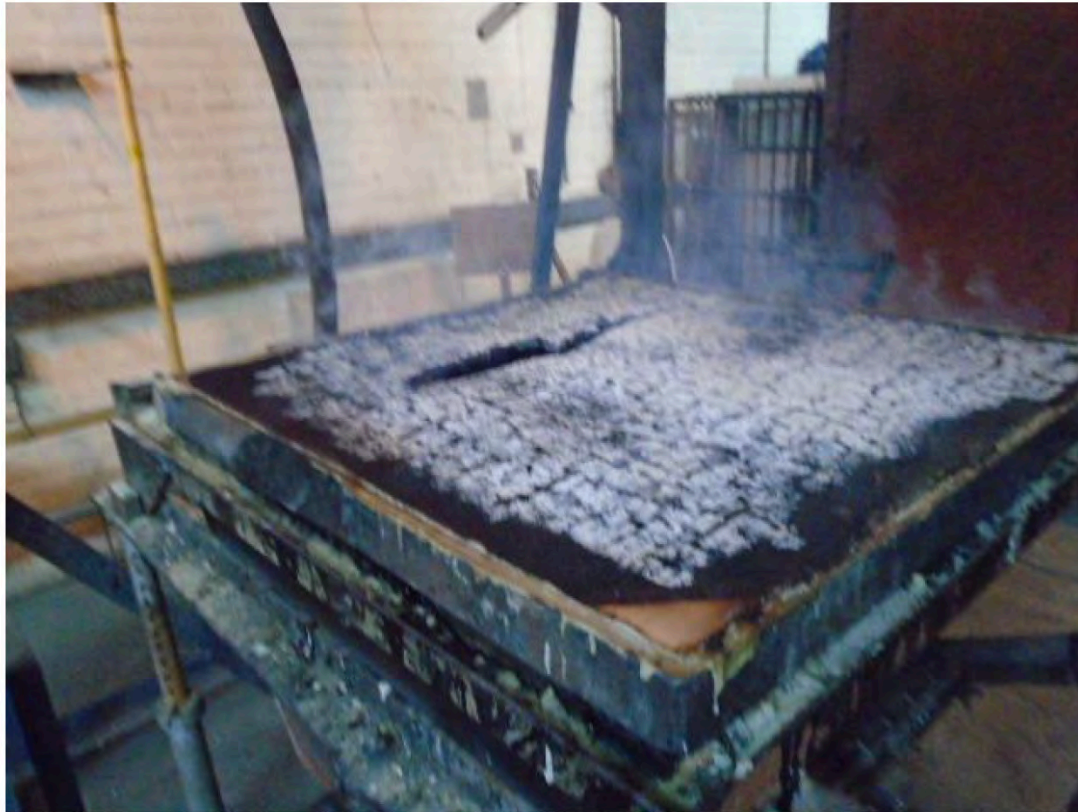
Figure 9- showing the failure at 40 minutes.

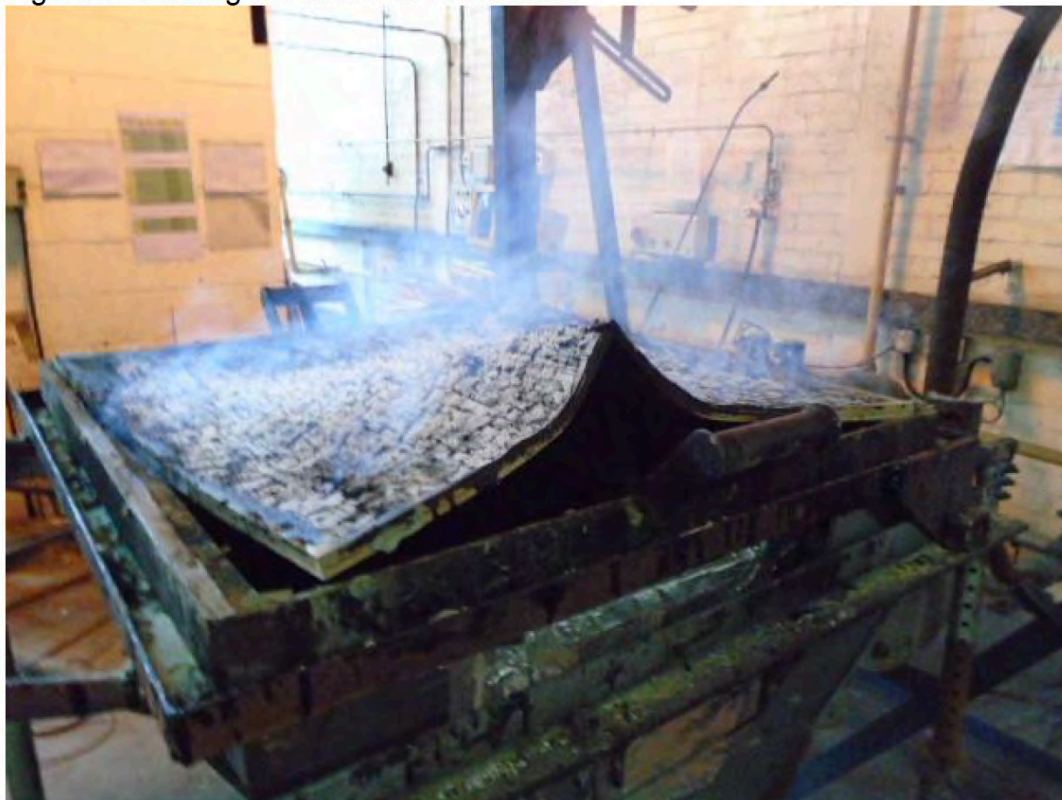
Figure 10- showing severe warping of test specimen 2 at approximately 36 minutes.

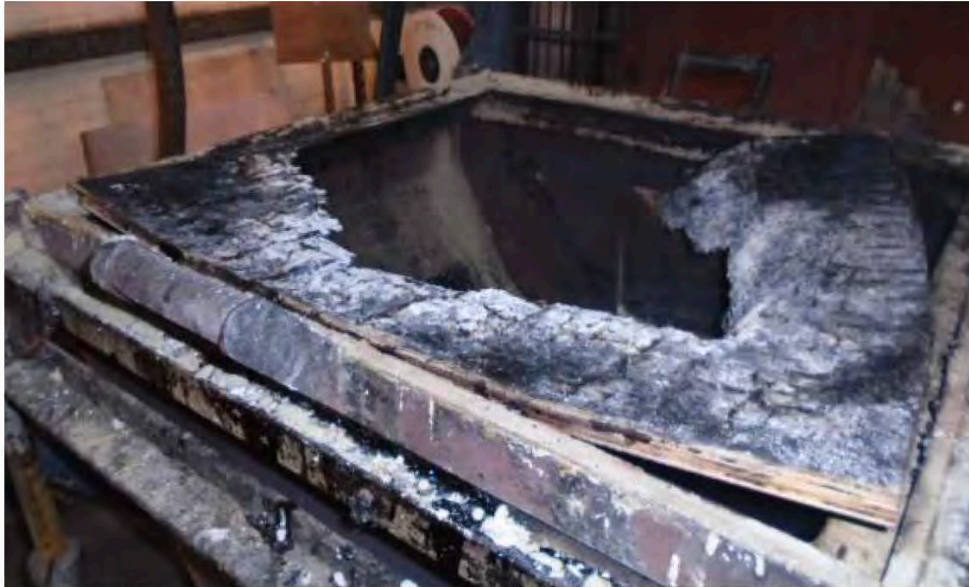
Figure 11- showing failure due to collapse of specimen 2 at 43 minutes.

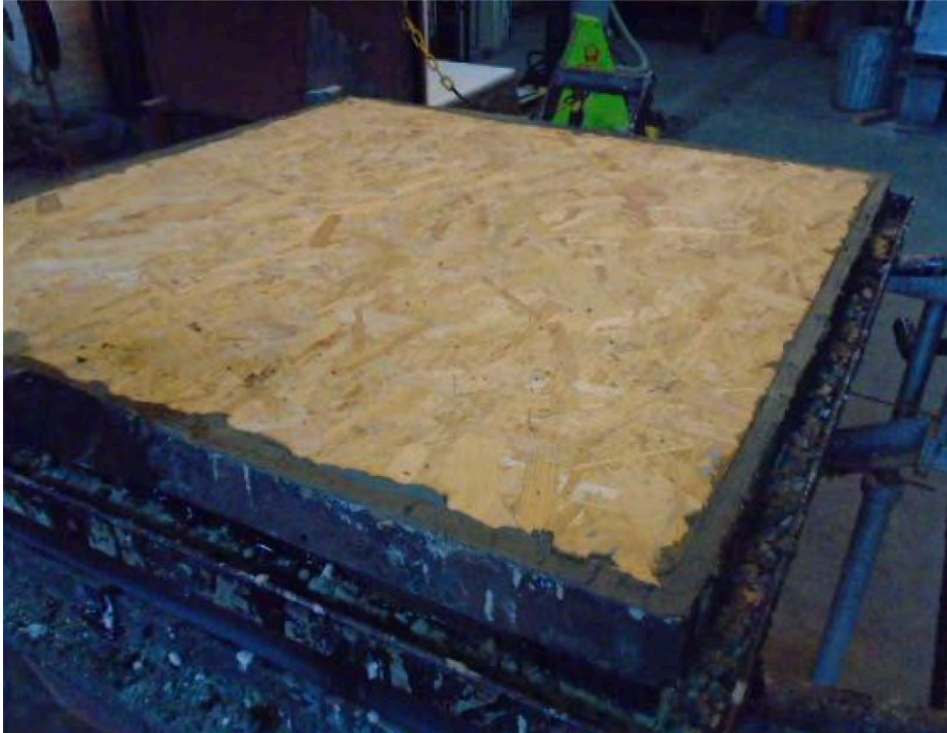
Figure 12- OSB board test 1 as installed prior to testing.

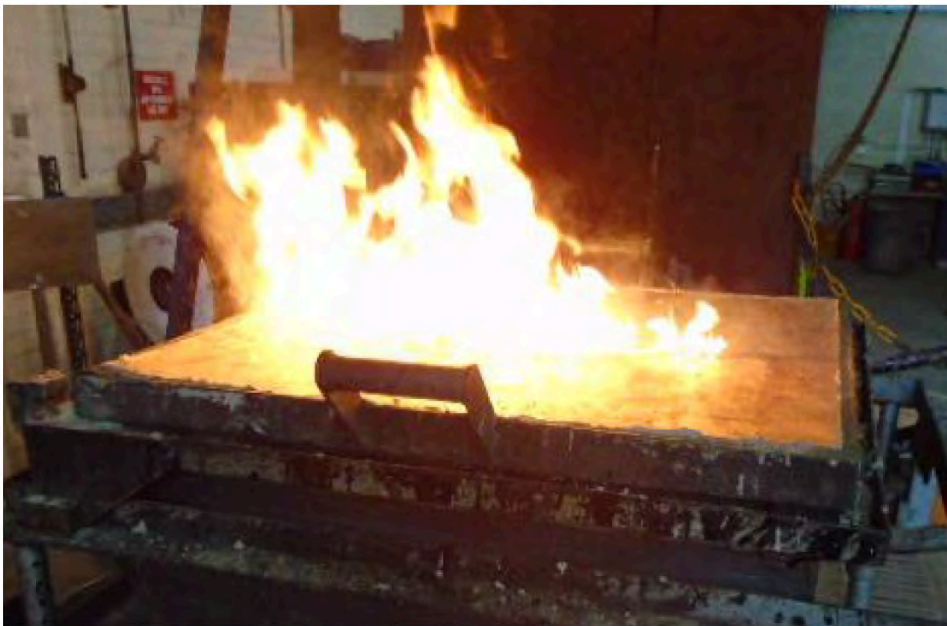
Figure 13- Flaming of test 1 as seen at approximately 6:15 minutes.

Sample reference	Penetration min:s	Observations
E11181-1	N/A	Specimen ignited with test pilot flame at 5 minutes and flames grew until they threatened to envelop the gap pipes above the test rig. The test therefore had to be terminated by extinguishing with a hose at 6:30 minutes.
E11181-2	N/A	Specimen ignited with test pilot flame at 5 minutes and flames grew until they threatened to envelop the gap pipes above the test rig. The test therefore had to be terminated by extinguishing with a hose at 7:00 minutes.

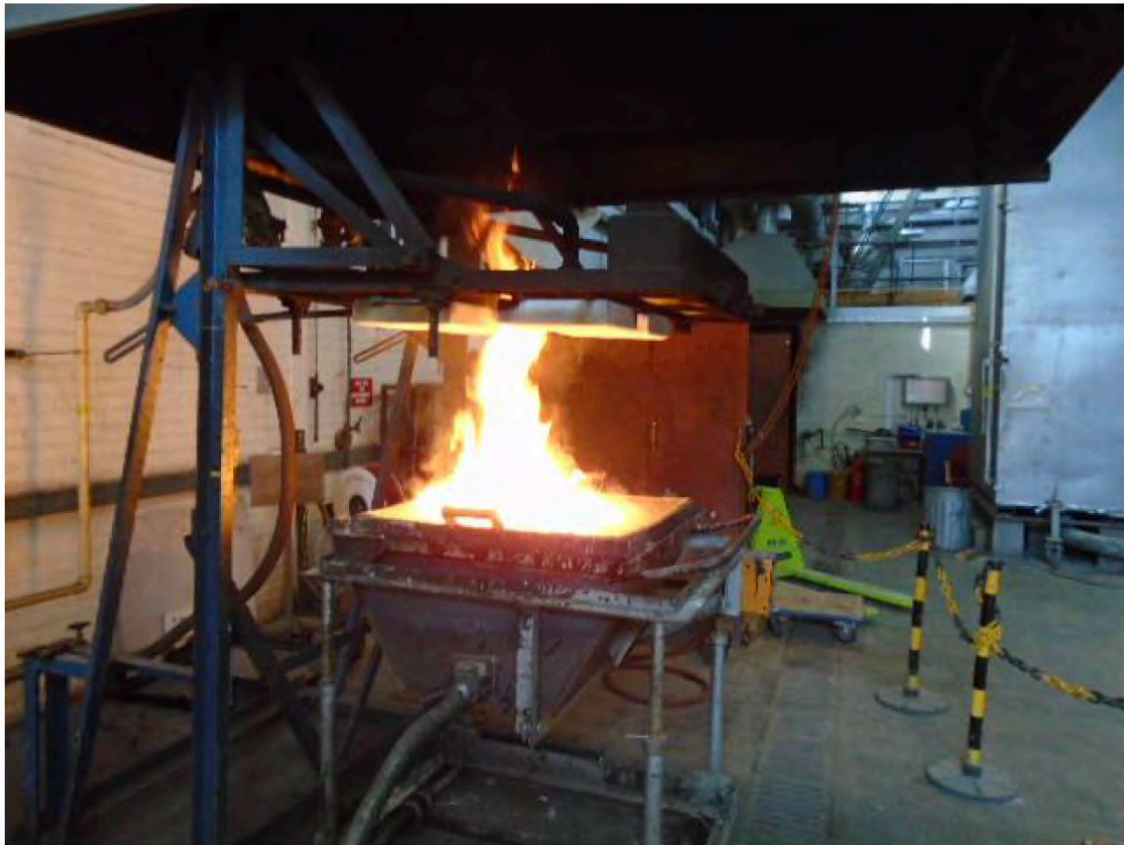
Figure 14- Test 1 immediately before test stopped at 6:30 minutes due to flames threatening gas pipes above test rig.

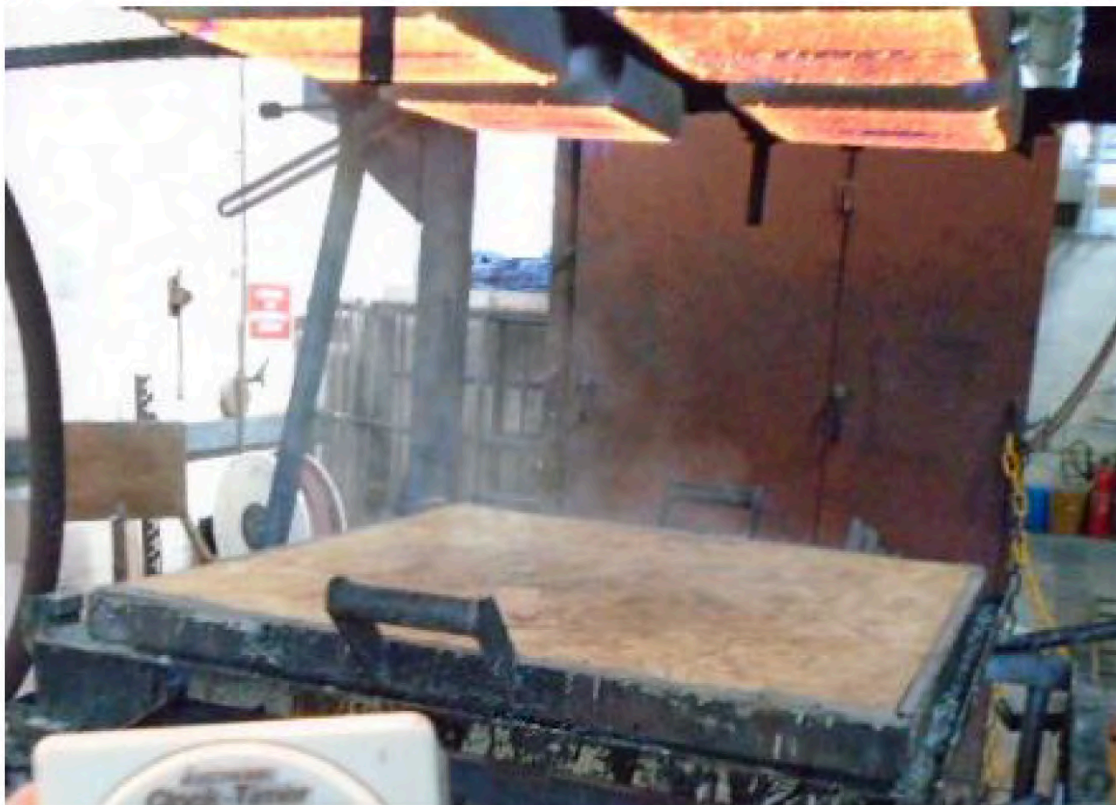
Figure 15- Test specimen at 4:25 minutes, prior to ignition.

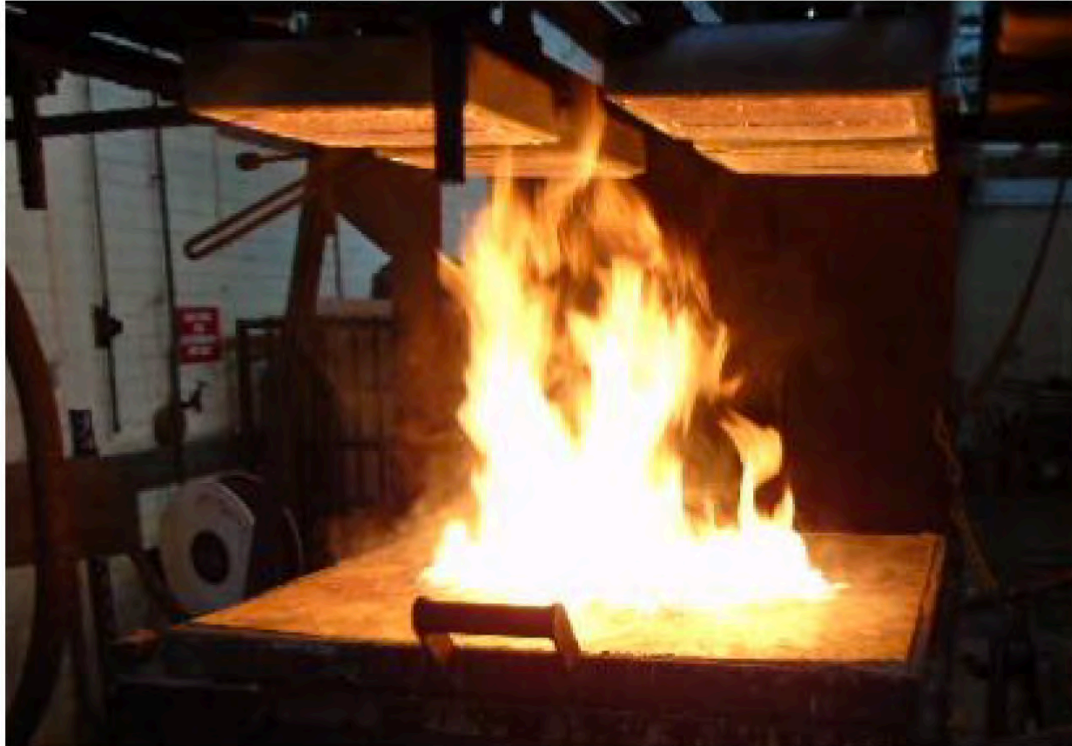
Figure 16- Flaming of test 2 as seen at 6:22 minutes.

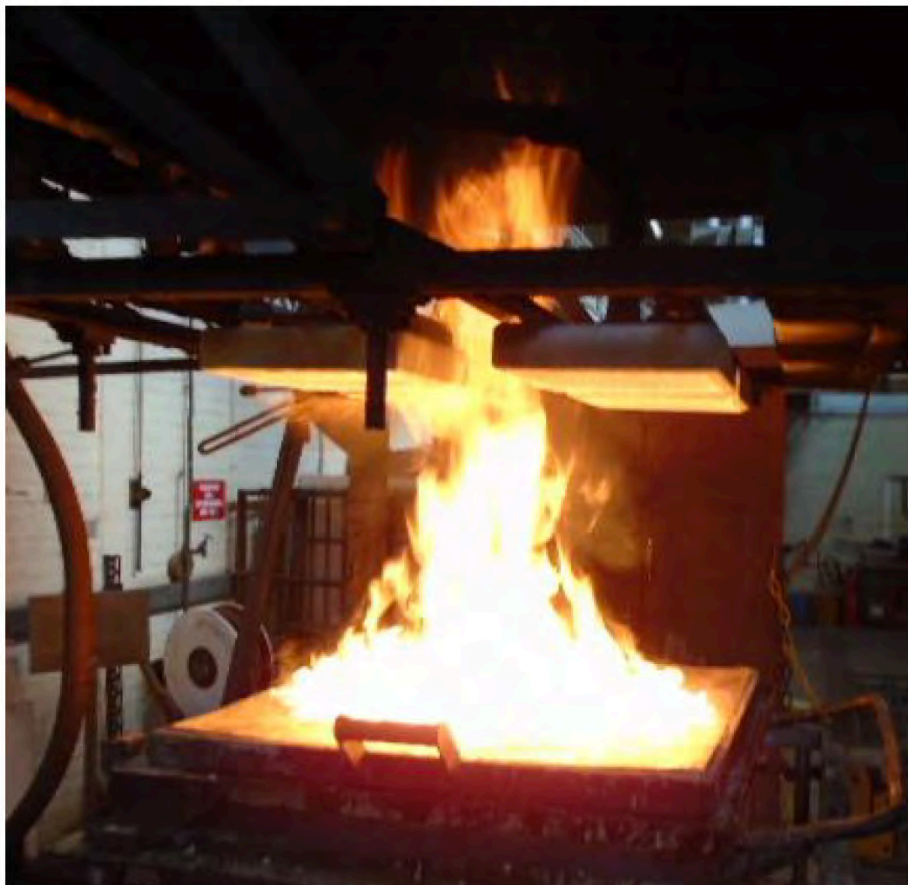
Figure 17- Test 2 immediately before test stopped at 7:00 minutes due to flames threatening gas pipes above test rig.

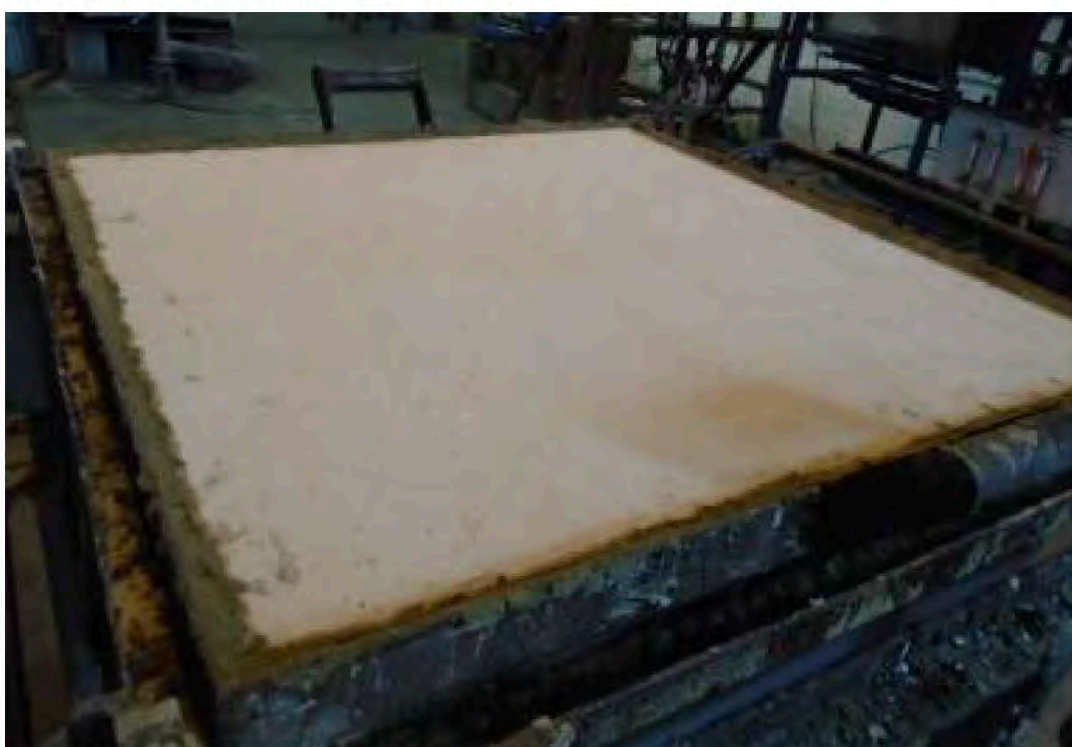
Figure 18- Test specimen 1 immediately prior to testing.

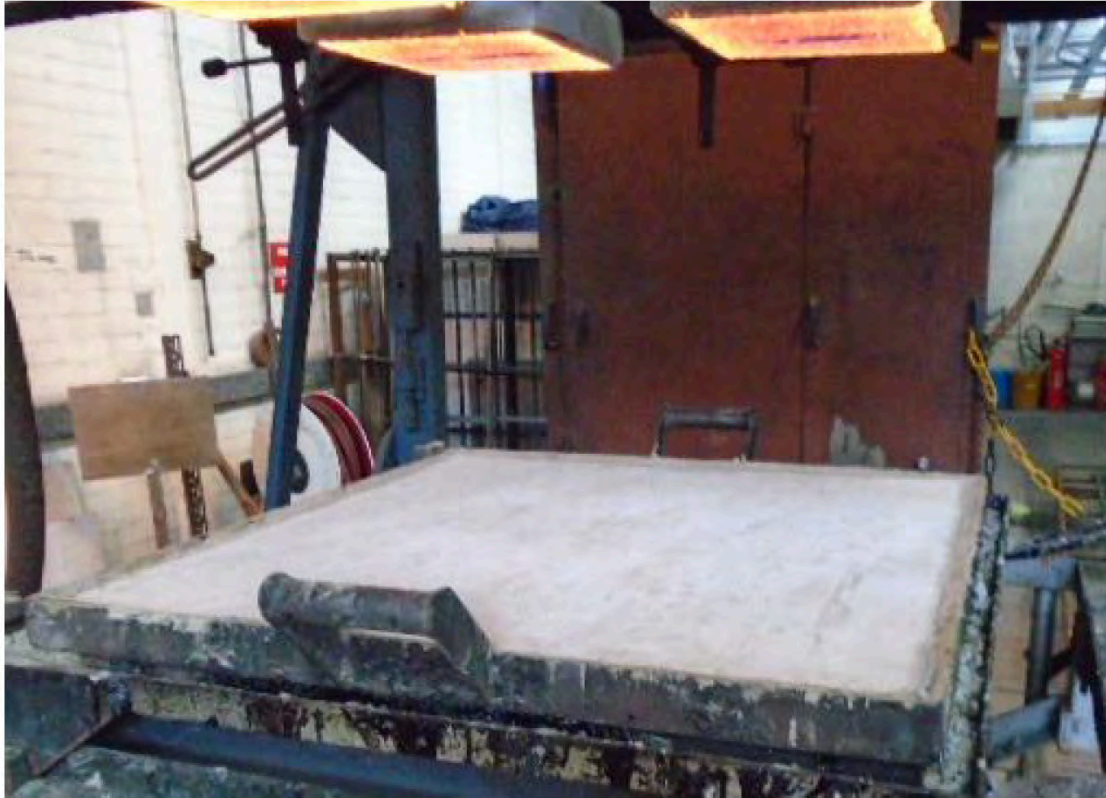
Figure 19- Test specimen 1 at end of 60 minute test.

Sample reference	Penetration min:s	Observations
E11179-1	None	No ignition or degradation of specimen visible.
E11179-2	None	No ignition or degradation of specimen visible.

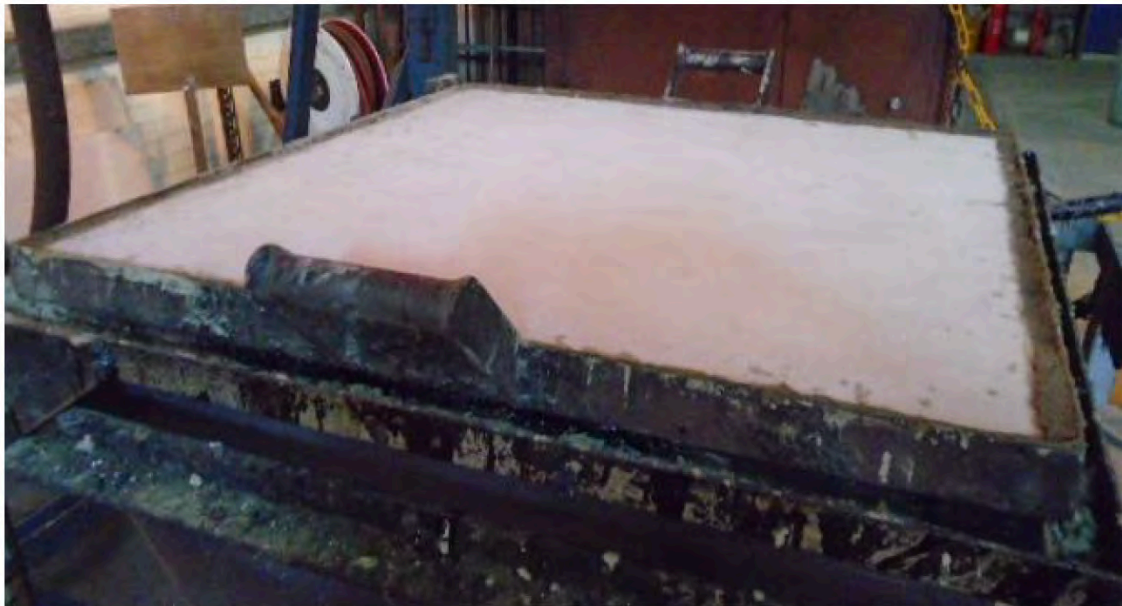
Figure 20- Test specimen 2 immediately prior to testing.

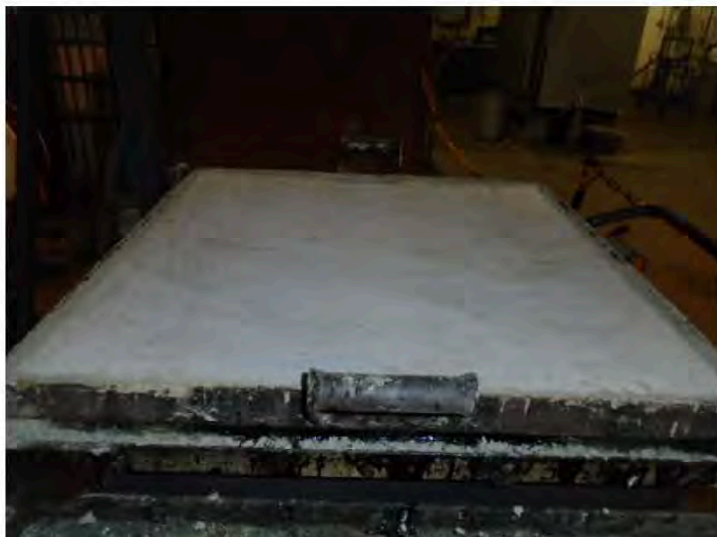
Figure 21- Test specimen 2 at end of 60 minute test.

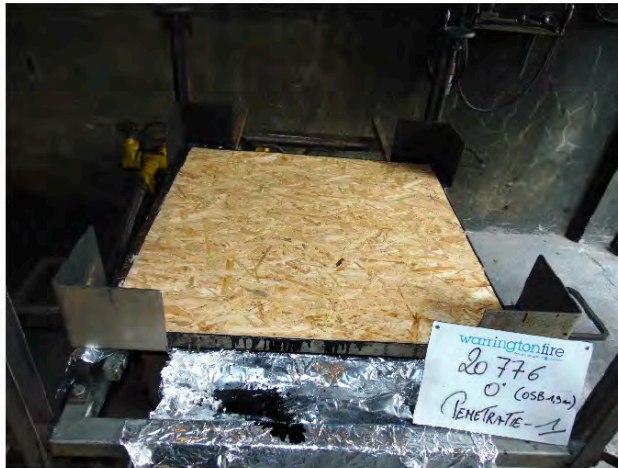
Specimen 1: Before

Photo of the test specimen before and after the test

Specimen No:	1	Average
Time to fire penetration (min:sec)	16:41	N/A
Nature of the penetration	glowing	N/A
Additional observations: panel ignited, flame out after 16:41, glowing in the corners, corners curl upwards, carbonization
